MANAGEMENT OF A MAJOR SLOPE FAILURE AT NCHANGA OPEN PIT,
CHINGOLA, ZAMBIA.

SDN Wessels, Head of Rock Mechanics, NOP
WA Naismith, Principal Consultant, SRK

Synopsis:

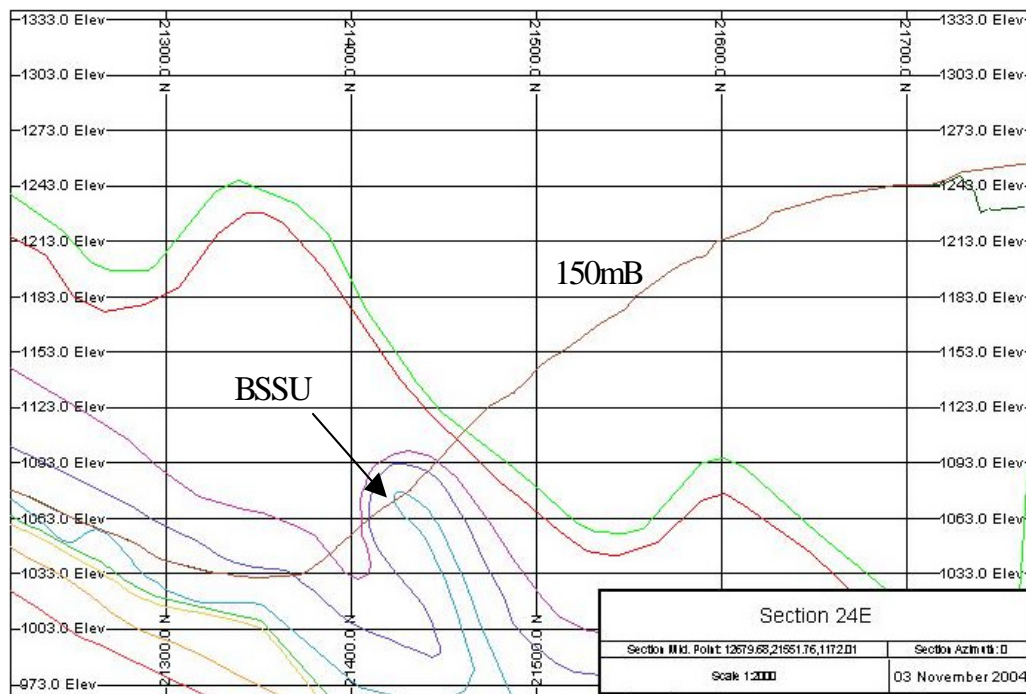
In July 2003, some monitoring points exhibited above average displacements and increases in movement rate. These lay in a specific area between 23E and 24E and from the 150m bench to the 225m bench. The increase in movement rates coincided with exposure of a small zone of Upper Banded Sandstone in the core of a tight fold structure on the 270m – 285m bench. Figure 1 shows a section through the slope at 24E illustrating the geological structure in the face. There was no obvious geological relationship between the elevation at which mining was taking place and the elevation at which deformation was occurring. It was surmised that displacement of vertical joint planes associated with the fold reduced confinement applied to the overlying Chingola Dolomite and subsequent compression of this strata was transferred to overlying strata as settlement.

Figure 1: A section through the AOC indicating the geology. Note the exposure of the Upper Banded Sandstone (BSSU) in the nose of the fold.

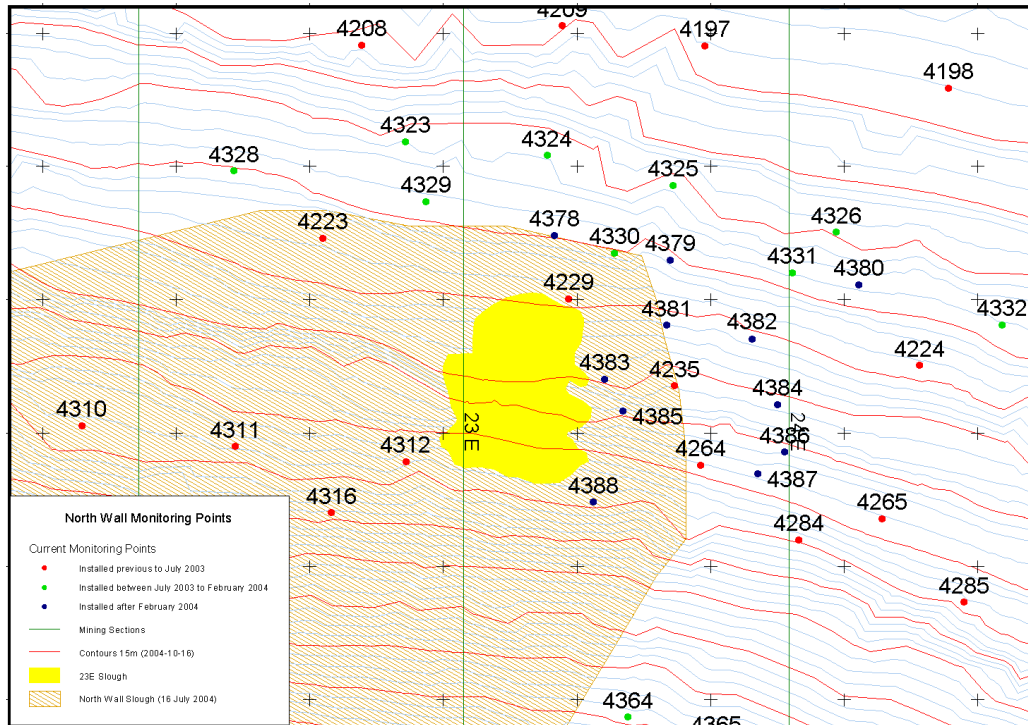
The location of monitoring points installed in the Area of Concern is indicated in figure 2. Shading indicates the position of the slough at the end of November 2003, and the hatched area the extent of the July 2004 failure. Unfortunately, no monitoring points were installed in the Area of Concern below 225m bench due to a combination of logistical and safety considerations.

Figure 2: Monitoring points installed on North Wall: up to MP4316- prior to July 2003; MP4323 to MP4332 - between July 2003 and February 2004; MP4380 to MP4388 - after February 2004

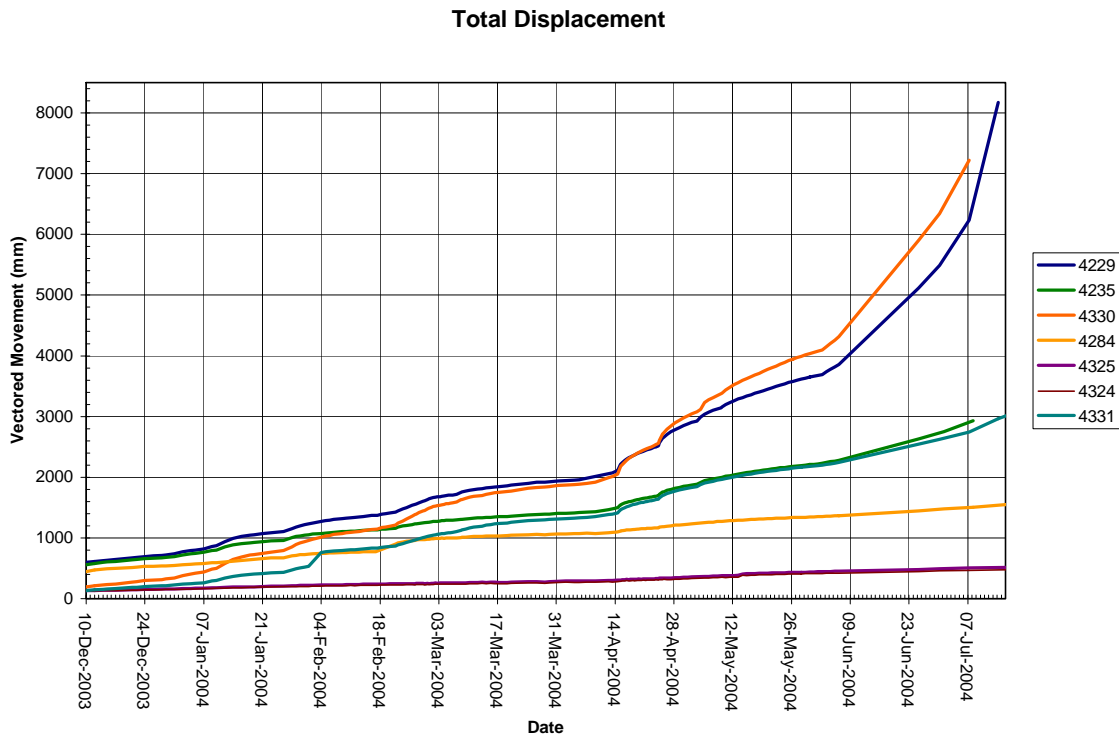
Figure 3 indicates the total displacement measured for a selection of monitoring points for the period from December 2003 to July 2004. Three groupings of points are evident: -

- MP4330 and MP4229 lie in the area of collapse and have undergone approximately 6500mm and 7500mm of movement respectively over the period. MP 4229 appears to approach its asymptote in the period following 7th July.

- MP4235 and MP4331 both exhibit over 2500mm of displacement. Whereas MP4235 lies on the margin of the collapsed zone and could be expected to move considerably, MP4331 lies some 60m from the margin and could be expected to exhibit movements of the same order as MP4325 which was installed at the same time. That it has not done so could be indicative of some local anomaly not associated with the main collapse.

- MP4325 and MP4284 lie outside the area of collapse and have remained relatively unaffected. MP4325 has undergone approximately 400mm of movement as would be expected with a background rate of 2mm/day over the period. MP4284 has undergone approximately 1000mm of deformation. This is far more than would be expected from the

background rate and it is probable that this point has been subjected to a local anomaly.

From examination of the selection of points shown in figure 3, it is clear that no unequivocal information regarding either the extent of the area of potential collapse or its likely time of collapse can be gleaned. The degree of uncertainty involved in making those predictions and in developing criteria by which to allow men and equipment to work safely is high and criteria must therefore err on the conservative side.

Figure 3: Total displacement of selected monitoring points from 10 December 2003 to 7 July 2004

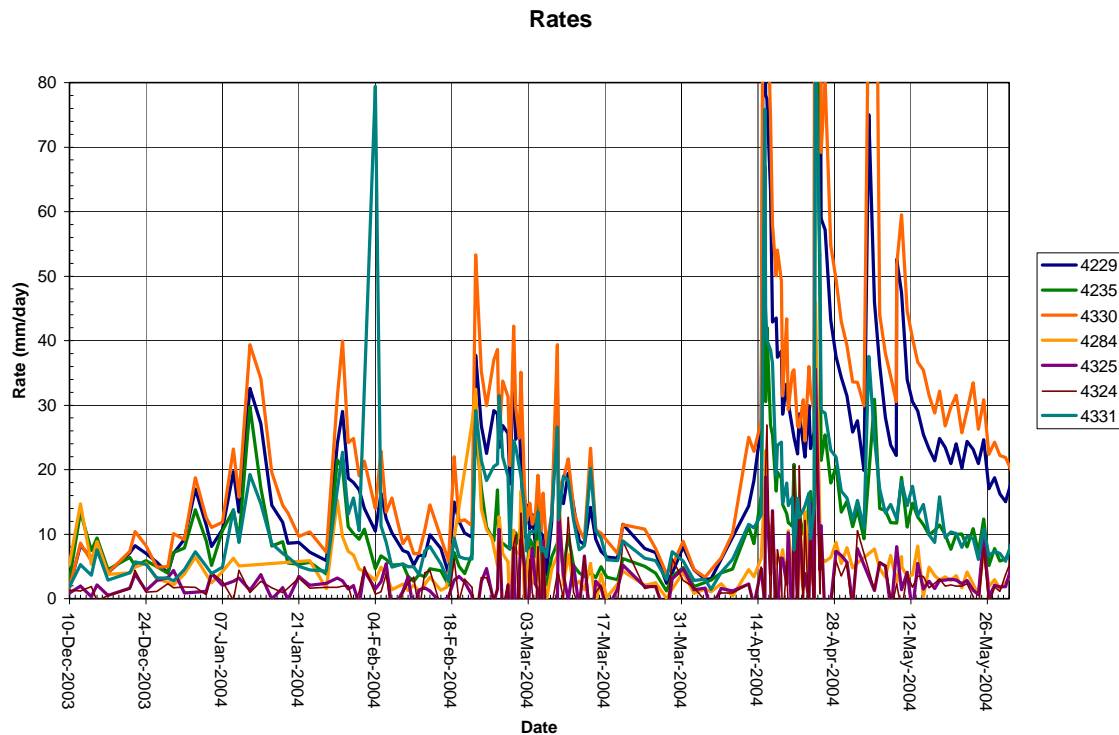
Figure 4 illustrates deformation data that has been converted into movement rates for the period December 2003 to May 2004. The response of deformation rate to blasting is clearly visible, particularly in April and early May when a series of blasts within the Area of Concern appear to have changed the longer term pattern of rate increase and decay. Prior to April, following a blast, rates would increase and then decay to pre blast levels. From the May blast, movement rates have taken much longer to decay and monitoring points lying within the collapse area, MP4229 and MP4330, have decayed to rates much higher than those pre blast. This is perhaps indicative of a change in strength characteristic of the slope from one of primarily peak shear strength to that approaching residual shear strength.

Figure 4: Movement Rates: 10 December 2003 - 19 May 2004

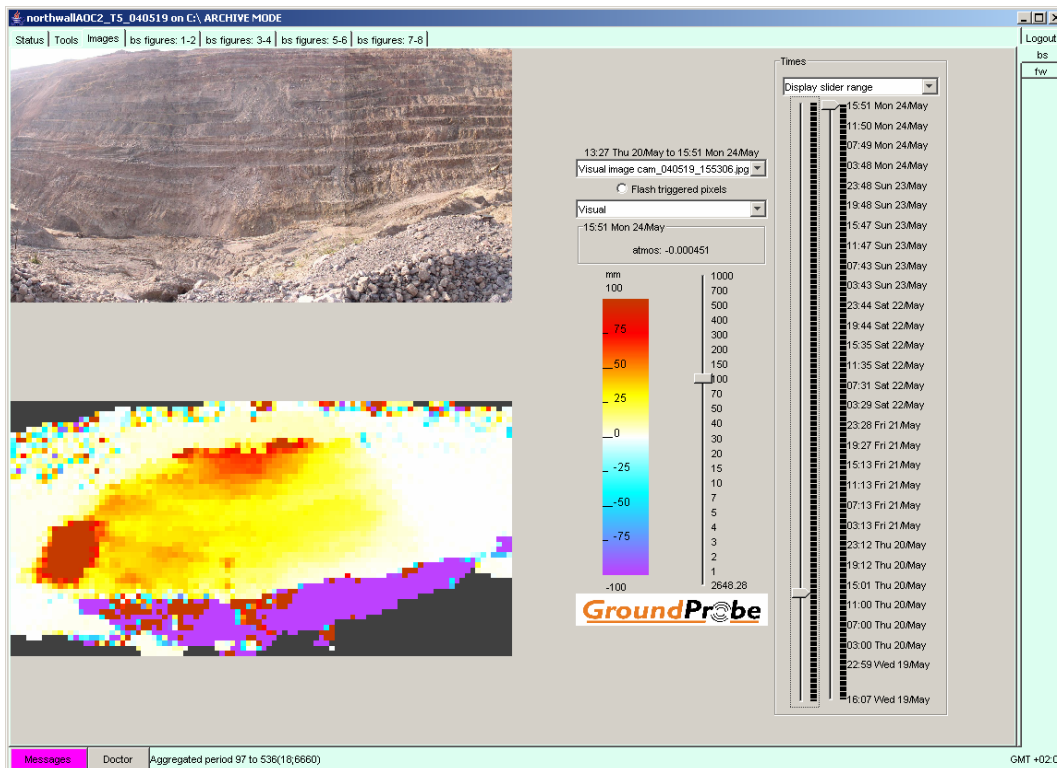
Scan duration was approximately 14 minutes and results were sent to a computer in the control centre via a radio link. Time-displacement plots and movement rates were plotted from the results. Trigger levels were determined and applied to particular higher risk areas and set to raise an alarm automatically should they be exceeded. An example of a screen display is shown in Figure 5. From this figure it is possible to distinguish an area of increased deformation from a background, relatively static area and also to distinguish two zones of much higher deformation within the overall deforming area.

Figure 5: Initial Radar Survey Results-figure showing information that is relayed from the deployed unit to the central site. On screen, warmer (more dense) colours to the bottom right and upper central portions of the figure indicate greatest movements within the monitoring duration.

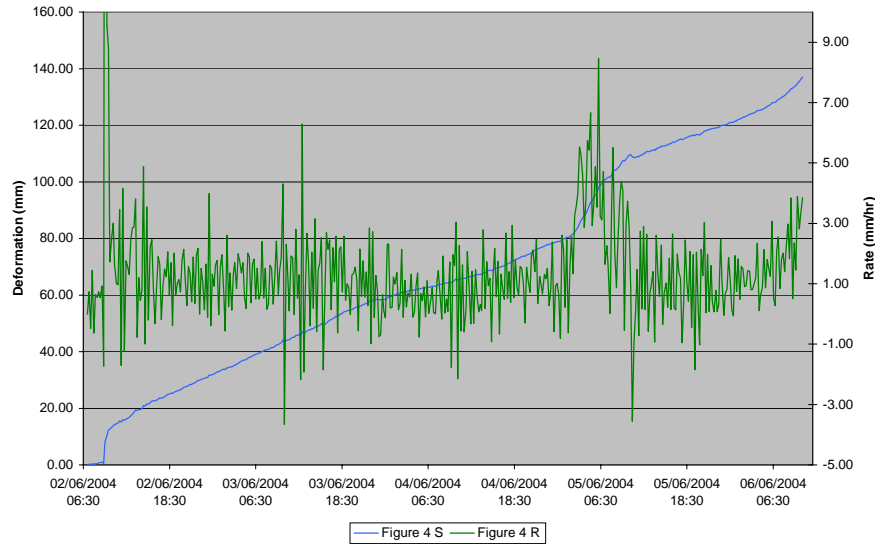
A combined displacement and movement rate graph is shown in figure 6.

Figure 6: Typical deformation and instantaneous movement rate plots derived from SSR data for a particular window. Note the variation in rate that often occurs between successive scans. A later variation to the software eased interpretation by smoothing the rate graph.

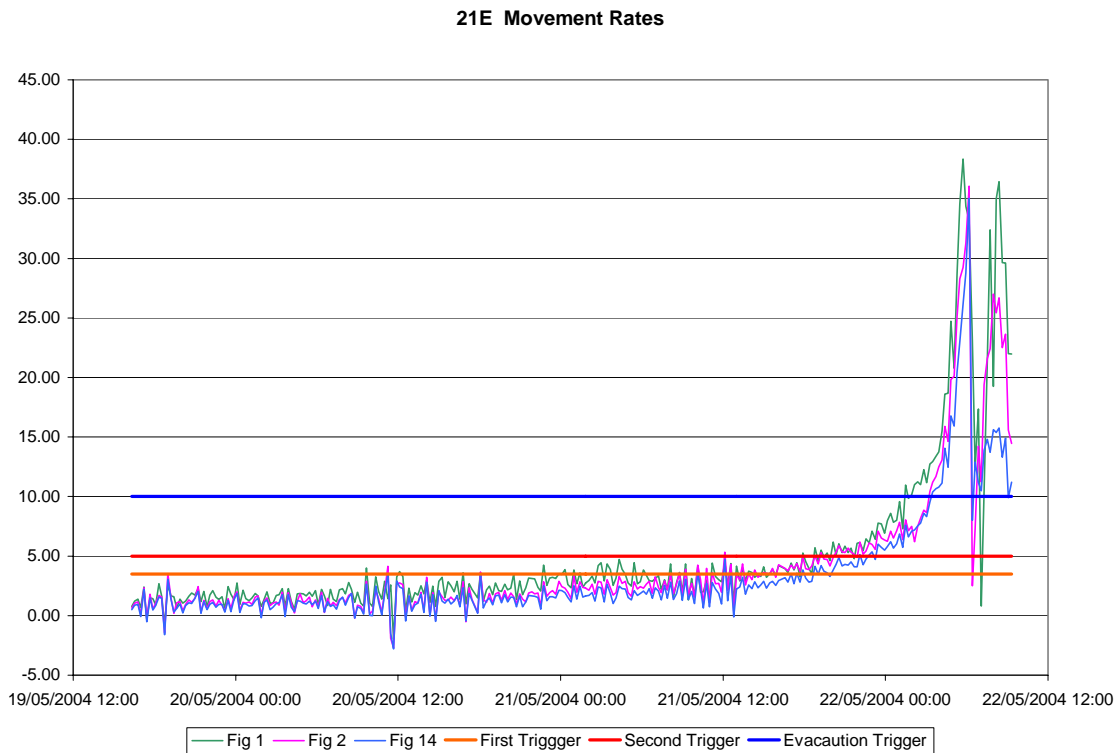
A back analysis was carried out on data obtained from an analysis window that was located retrospectively to cover the area of collapse. The displacement rates are indicated in figure 7. The following conclusions were drawn from the back analysis: -

- The increase in movement rates can clearly be seen in Figure 7. The change in rate of movement is a definite indicator of imminent collapse;
- There is no indication of the total amount of deformation that had taken place prior to collapse. Each time an SSR scan commences the displacement automatically starts from zero and there is no indication of previous displacements. Any predictive criteria based on deformation therefore is inappropriate;
- At approximately 12 hours prior to collapse an instantaneous rate of 3.5mm/hour was exceeded;
- At approximately 6 hours prior to failure an instantaneous rate of 5mm/hour was exceeded;
- At approximately 2 hours before failure an instantaneous rate of 10mm/hour was exceeded.

Figure 7: Back Analysis - 21E Failure figs 1, 2 and 14 refer to different windows placed retrospectively on the area. Trigger rates derived from the analysis are indicated by horizontal lines.

As these time intervals were considered acceptable in order to successfully evacuate men and equipment from the area of concern, they were adopted as “alert”, “alarm” and “scram” warning levels with associated management responses as indicated in Table 1: -

Trigger Level	Response
3.5mm/hour	ALERT: Increase frequency of rate calculations to every 30 minutes
5.0mm/hour	ALARM: Increase frequency of rate calculations to every 15 minutes Inform Control Tower of Alarm status. Inform Geotechnical Engineer on duty.
10mm/hour	SCRAM: Immediate evacuation from Area of Concern

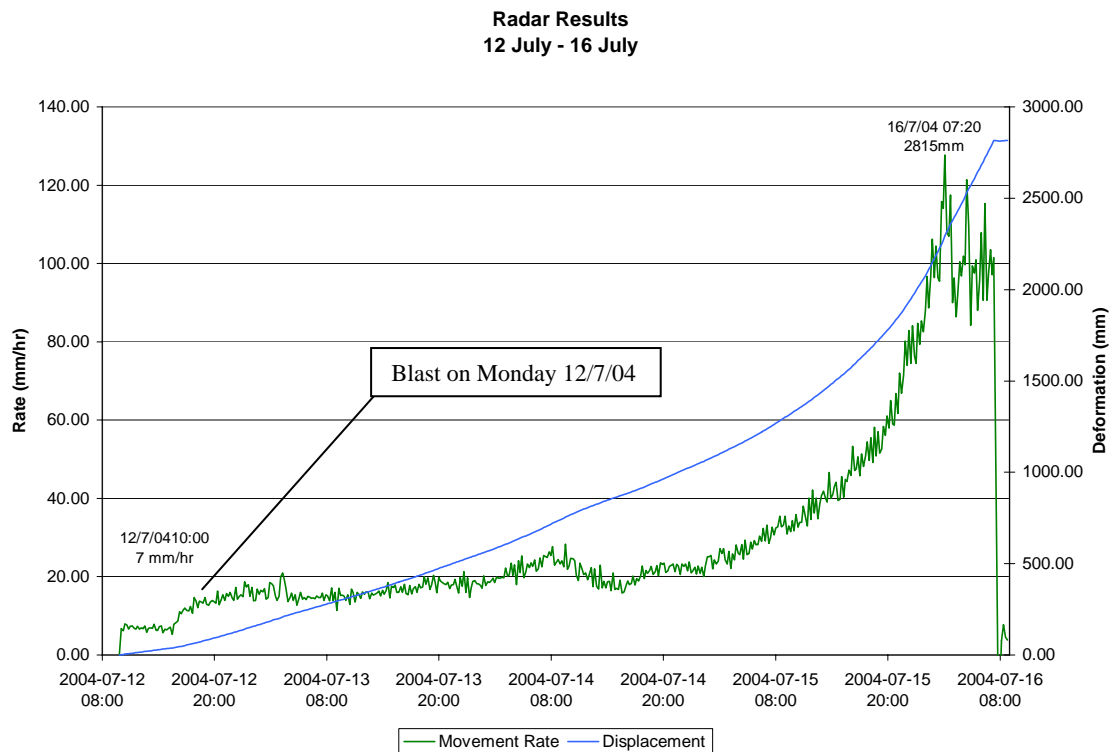
A constant displacement rate averaging 2-3mm/hour was observed until the 9th July, when it started to increase. The reason for this change is unclear. By Sunday 11th July the rates had increased to between 5 and 10mm/hr. On Monday 12th July the rates suddenly

increased to 20mm/hr following blasting during the afternoon and continued at between 20 – 30mm/hr until early in the morning of Thursday 15th July (about 02:00). This continuing increase had not been observed previously and was considered indicative of a change in condition within the slope. Rates continued to accelerate throughout Thursday and a decision was made at 20h00 to withdraw men and equipment from mining operations lying between 20E and 21E and relocate them further West. At 06h30 on Friday 16th July, rates had increased to 70mm/hr, all operations within the pit were suspended and remaining men and equipment withdrawn although they were working over 200m West of the Area of Concern. Final collapse of the slope commenced at about 06h50 with sloughing and collapse of benches on 150-165m levels. The main collapse followed at 0710 when an estimated 4.5 million tons of rock moved and completely inundated the 330m bench from 21E to 23E. The change in movement rates in the days and hours leading up to collapse can be seen clearly in Figure 8. The maximum movement rate immediately prior to failure exceeded 100mm/hr.

Figure 8: Movement rates and displacement in the four days prior to collapse.
