END-OF-LIFE MODE OF FAILURE OF A ZINC SULPHIDE CONCENTRATE FLUIDISED BED ROASTER AND ITS REBUILDING

Mr C B Kohler, Mr S Venter, Dr N M Vegter, Mr E H O Meyer
Exxaro Zincor, Exxaro Technology

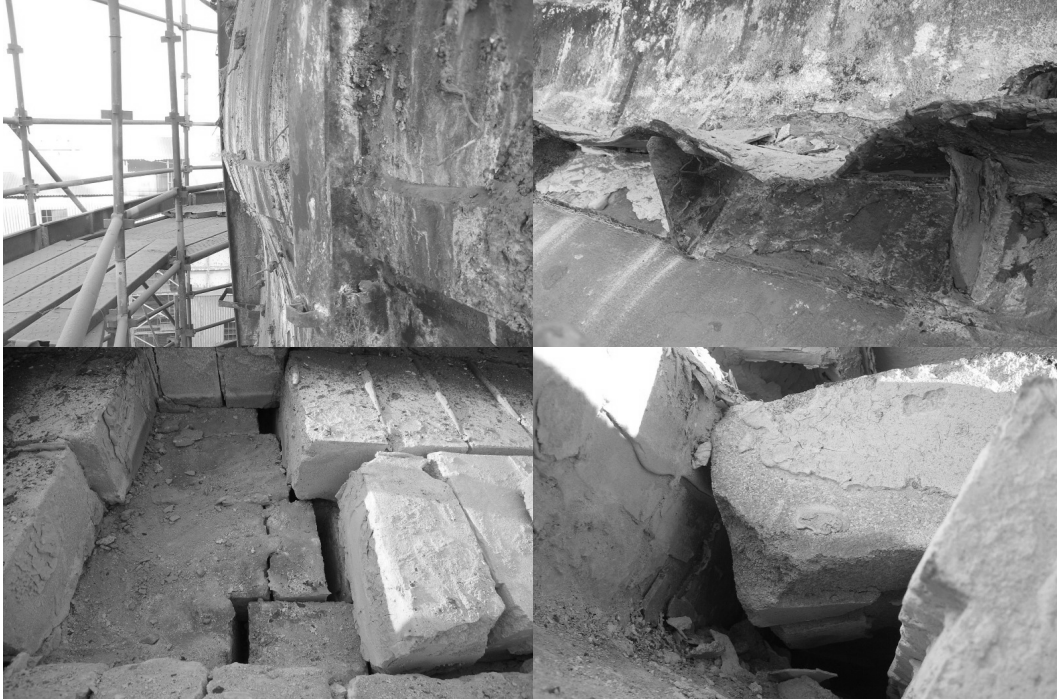
Pictures 1 to 4 – Roaster Damage

- The steel shell had buckled and warped. This had been exacerbated by temperature excursions beyond what the steel was designed for. This was due to a previous increase in the external insulation from 25mm to 100mm in an attempt to increase steam production. The steel part of the dome had also started to sag due to temperature excursions.

- The buckling of the roaster shell had caused the dome to start moving. Combined with the dome sagging, radial cracks had formed in the dome refractory lining.

- The combination of the buckling shell and moving dome had damaged the refractory lining of the shell, causing crumbling of the bricks.
- Due to frequent shutdowns and poor roaster draft control, gas which had permeated through the brick lining and gaps had cooled and passed through the dewpoint, forming acid against the steel shell. This had corroded several parts of the shell.

- The bricking rings in the freeboard had been oxidised away, leaving little support for the shell refractory lining.

(clockwise from top left: buckled steel shell; deformed and corroded bricking ring; collapsing and damaged bricks in roaster dome; radial crack in roaster dome brickwork)

On previous major shutdowns, reinforcing bars had been welded to the outside of the shell in an attempt to halt the warping. The brickwork had also been patched where possible. The damage to the roaster was so extensive that a major rebuild from the tuyere plate upwards was required.

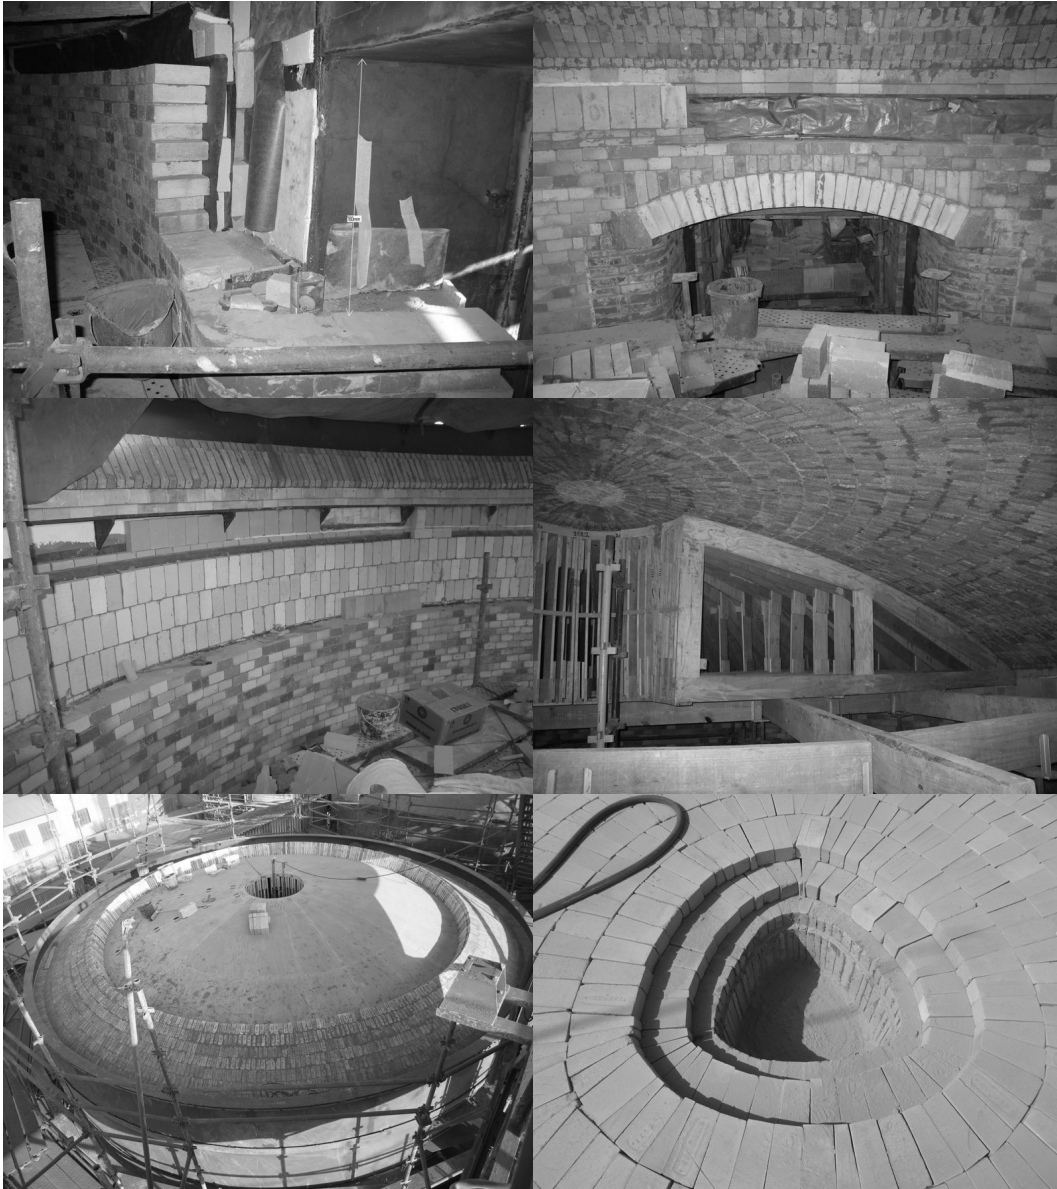
Pictures 5 to 10 – Roaster 3 Rebuilding

(clockwise from top left: wall insulation showing boards, paper and bricks; roaster exit into the boiler; removal of the dome former; top of the dome before the plug is cast; laying the dome bricks; brickwork at the top of the freeboard before the dome is installed)
